Insured/Applicant Name:		Application	on / Policy #:		
Address Inspected: Lake Worth, FL 33467					
Actual Year Built: 2001	Date Inspected: 03/10/2025				
Minimum Photo Requirements: ☑ Dwelling: Each side ☑ Roof: Each slope ☑ Plumbing: Water heater, under cabinet plumbing/drains, exposed valves ☑ Main electrical service panel with interior door label ☑ Electrical box with panel off ☑ All hazards or deficiencies noted in this report A Florida-licensed inspector must complete, sign and date this form.					
Be advised that Underwriting will rely on the information in this sample form, or a similar form, that is obtained from the Florida licensed professional of your choice. This information only is used to determine insurability and is not a warranty or assurance of the suitability, fitness or longevity of any of the systems inspected.

Additional Comments/Observations (use additional pages if needed):					
Re-Roof Permit # B-2023-01	1397				
All 4-Point Inspection Forms must be completed and signed by a verifiable Florida-licensed inspector. I certify that the above statements are true and correct.					
Michael Strano Inspector Signature	CEO Title	HI9693 License Number	03/10/2025 Date

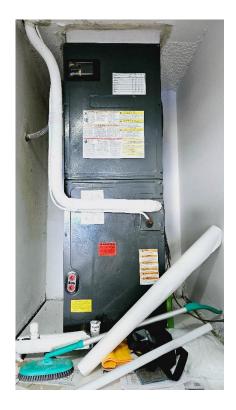
AC & HVAC Mfg Dates 2023 & 2022
